The unique chassis platform of a GILLIG Low Floor consists of a **stainless steel structure with integral side impact barriers**. To buffer the potential danger to these passengers, the chassis of the GILLIG Low Floor incorporates unique angled stainless steel protective side impact barriers. The force of an impending vehicle during a side impact incident is absorbed by these barriers and is directed downward and away from the passenger compartment.

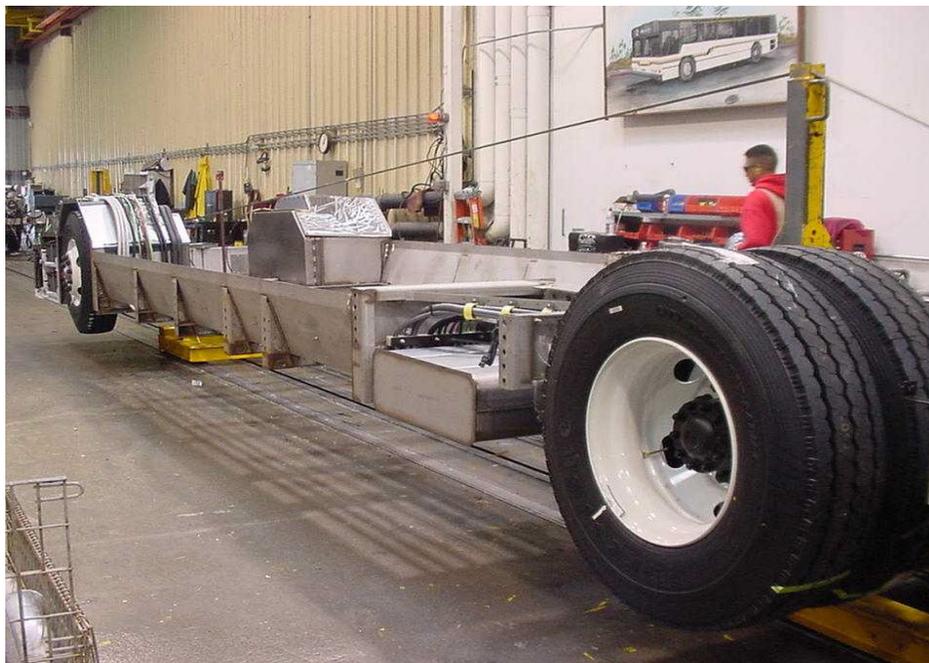
**Stainless Steel Chassis w/ Side Impact Barriers**

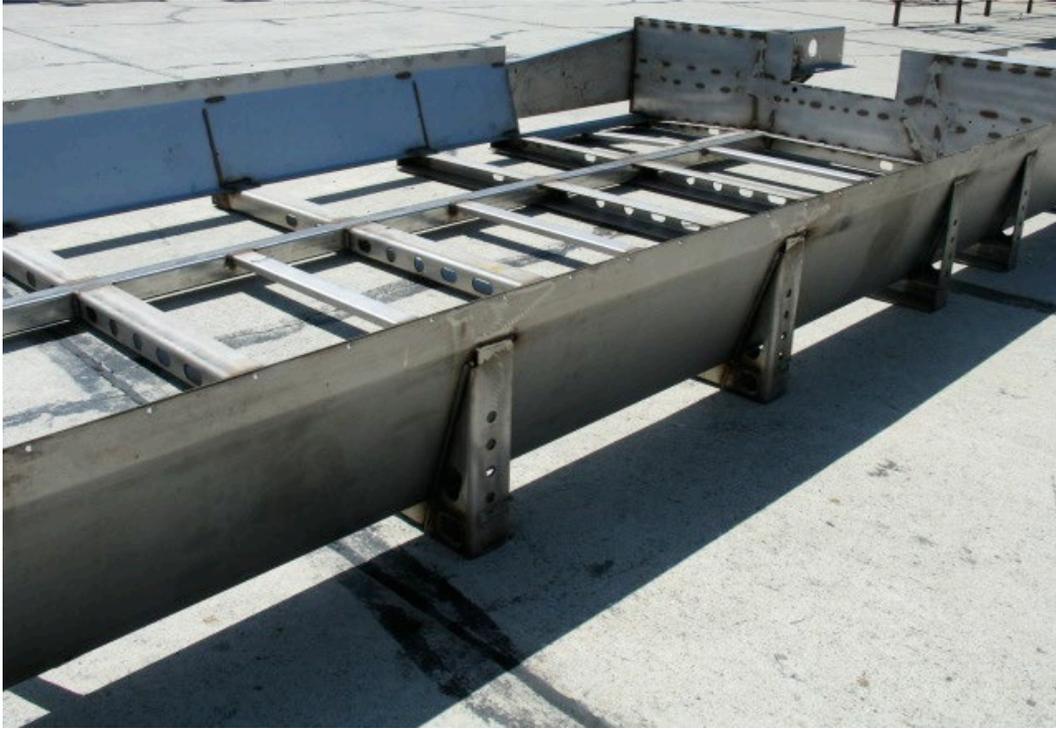
**Side Impact Barrier**

**The robust, integral side impact barrier has been designed to afford maximum collision security to passengers inside the low floor section of the bus.** This fifteen inch high barrier also provides a significant structural element by equipping the center section of the frame with a sturdy perimeter.

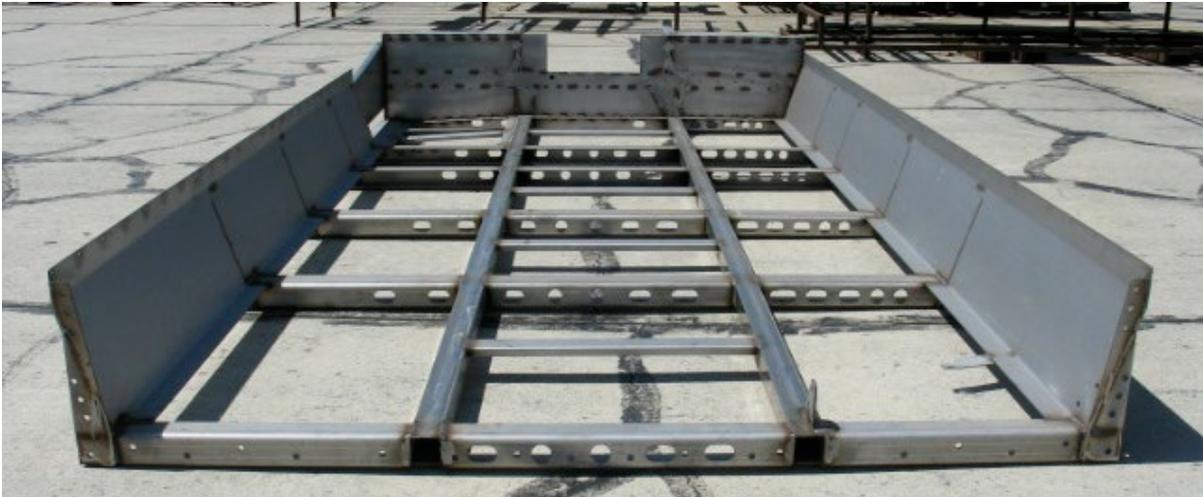
**Center Chassis Module with Crash Barrier**
